# SUPERIOR INSPECTION SERVICES, LLC

## \*\*\* Residential Inspection Report \*\*\*

September 6, 2011

800 Smith Lane  
Little River, SC 29566

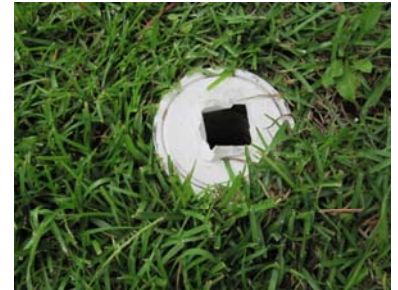
Cleanout plug needs to be replaced

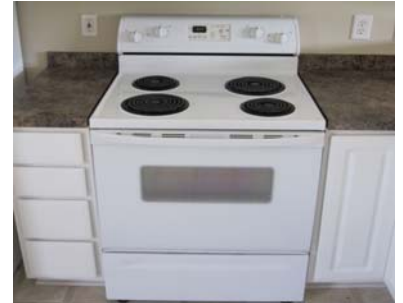
Anti-tip bracket is installed

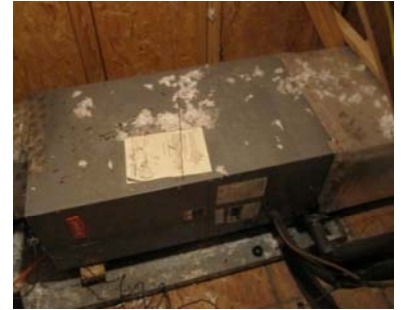
Drain line from attic pan needs a trap installed next to unit and the one outside removed.

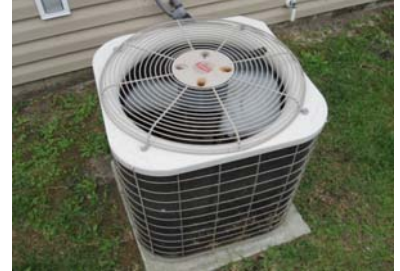
Armaflex insulation needs to be repaired

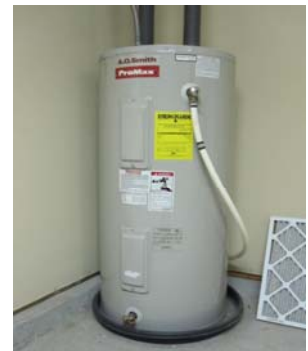
Both hot and cold feeds were installed with iron fittings and are badly rusted need to be replaced
